**TUCSON CITY HALL BUILDING**

Building Location: 255 West Alameda Tucson, Arizona

Date of Site Visit: 11/16/06

**Field Notes, Background & General Observations**

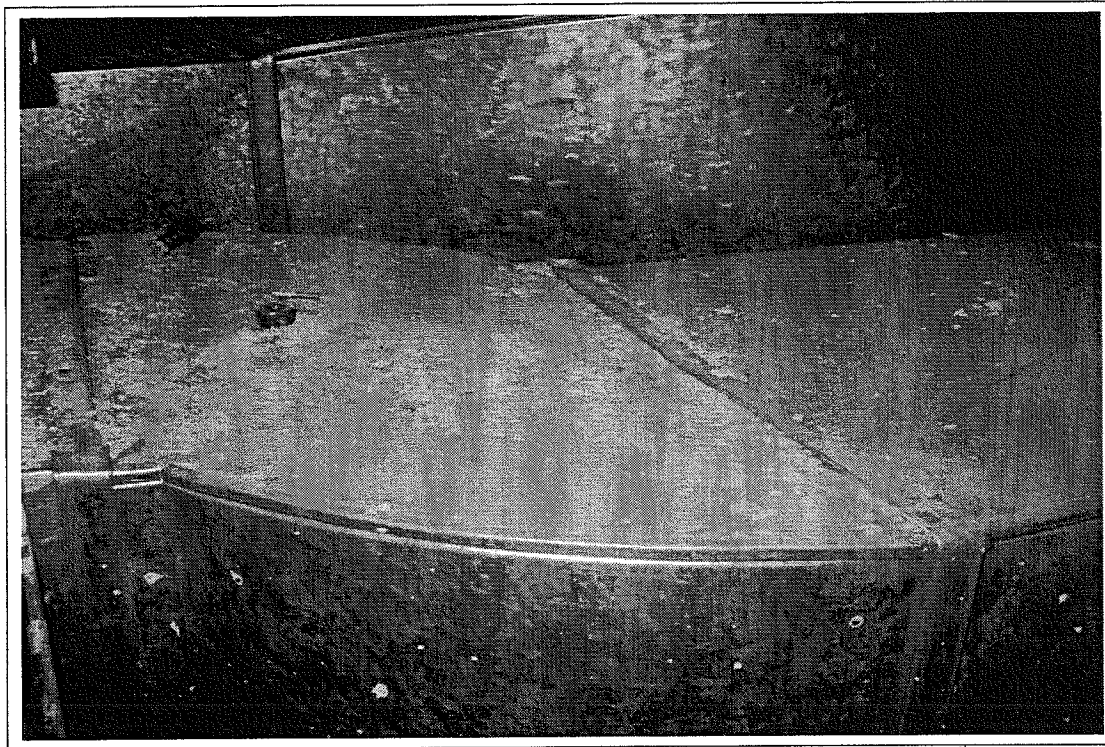
Photo 125. View of delaminated fireproofing debris on top of HVAC duct in 5<sup>th</sup> floor attic

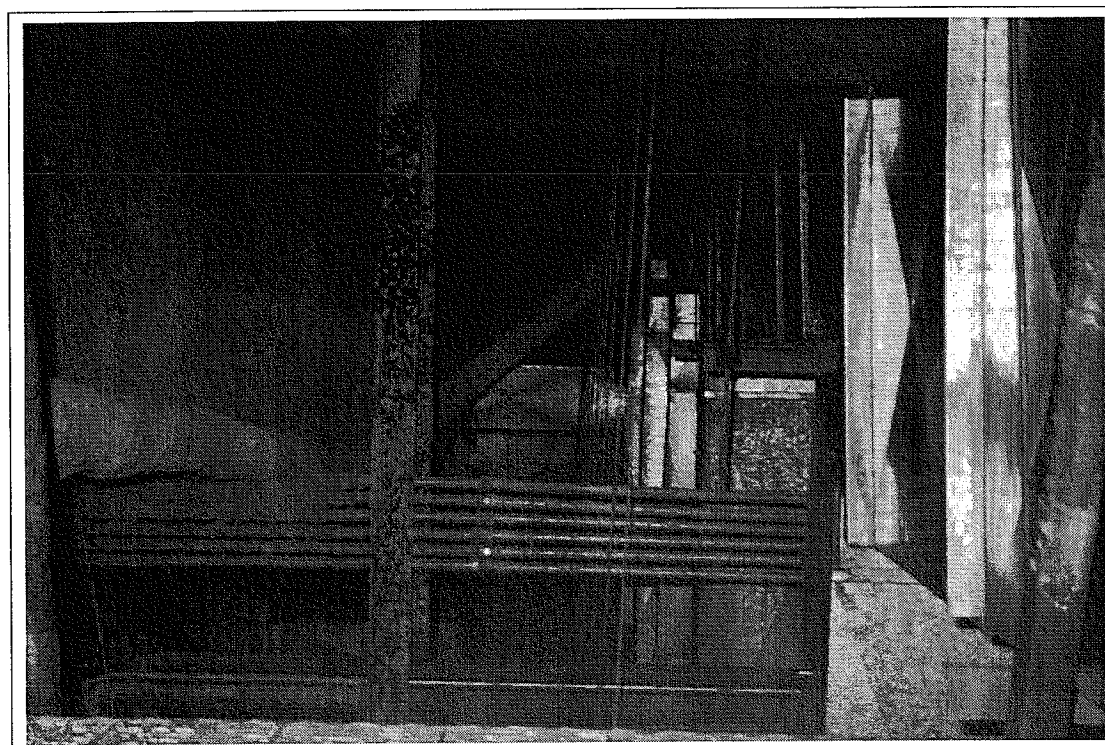
Photo 126. General view of fireproofing 5<sup>th</sup> floor attic

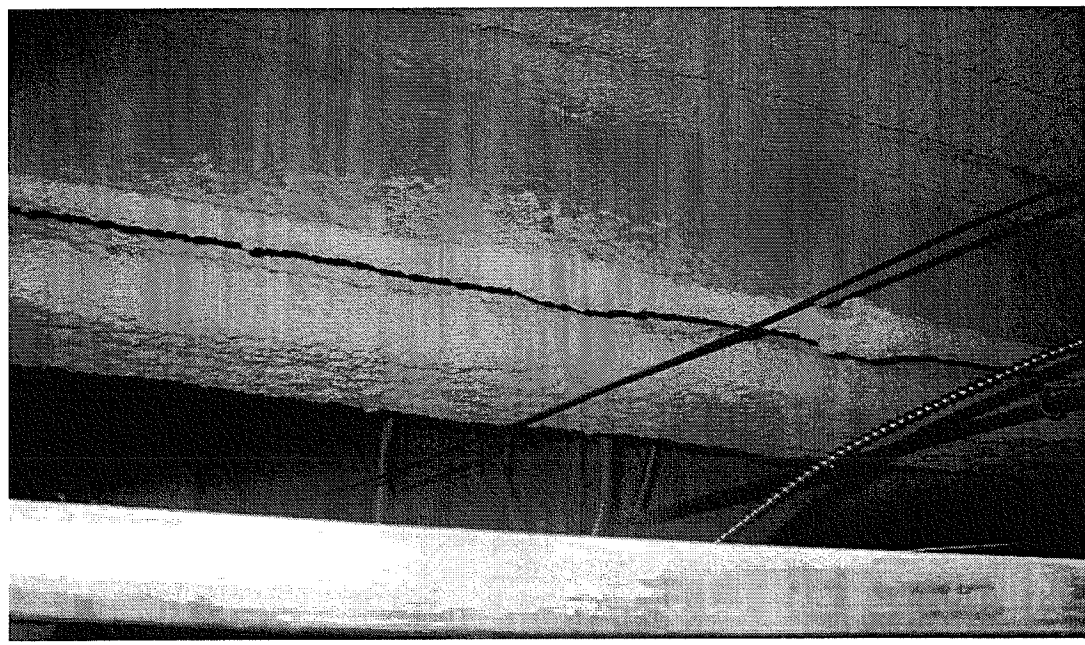
Photo 127. View of fireproofed I-beams and metal pan decking above suspended ceiling  
10th floor, W side - hallway outside Rm 1024

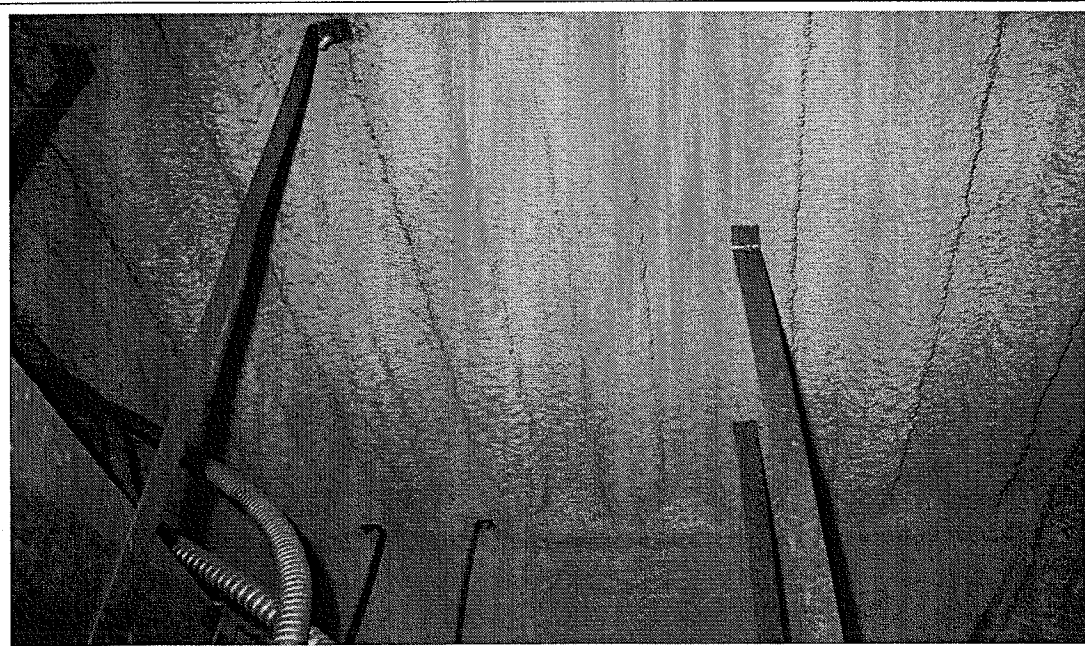
Photo 128. View of fireproofed corrugated metal pan decking above suspended ceiling  
10th floor, W side - hallway outside Rm 1024, Note HVAC hanger straps attached to  
fireproofed decking

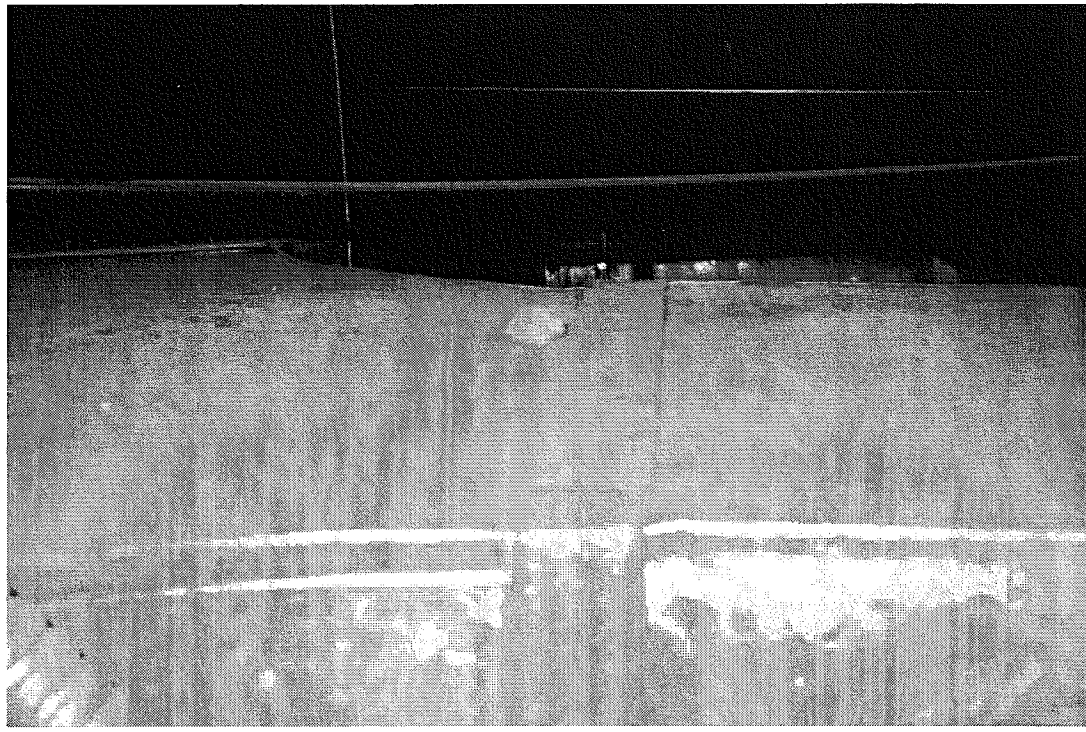
Photo 129. View of delaminated fireproofing chunk on top of HVAC duct above suspended ceiling 10th floor, W side - hallway outside Rm 1024

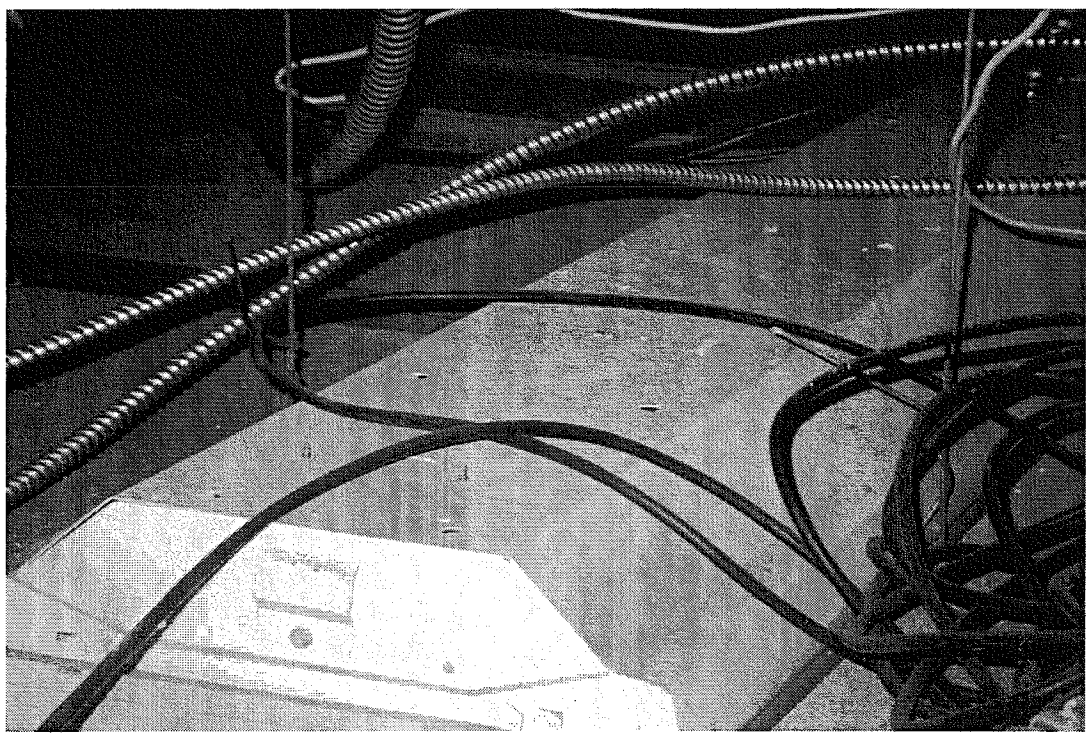
Photo 130. Delaminated fireproofing dust and debris on top of fluorescent light above suspended ceiling 10th floor, W side - hallway outside Rm 1024
